ARMY ENGINEERING DISTRICT NORFOLK VA  
NATIONAL DAM SAFETY PROGRAM, BEAVERDAM CREEK DAM (VA-01903), BE--ETC(U)  
JUL 79 J A WALSH

Name Of Dam: BEAVERDAM CREEK  
Location: BEDFORD COUNTY, VIRGINIA  
Inventory Number: 01903

# PHASE I INSPECTION REPORT NATIONAL DAM SAFETY PROGRAM

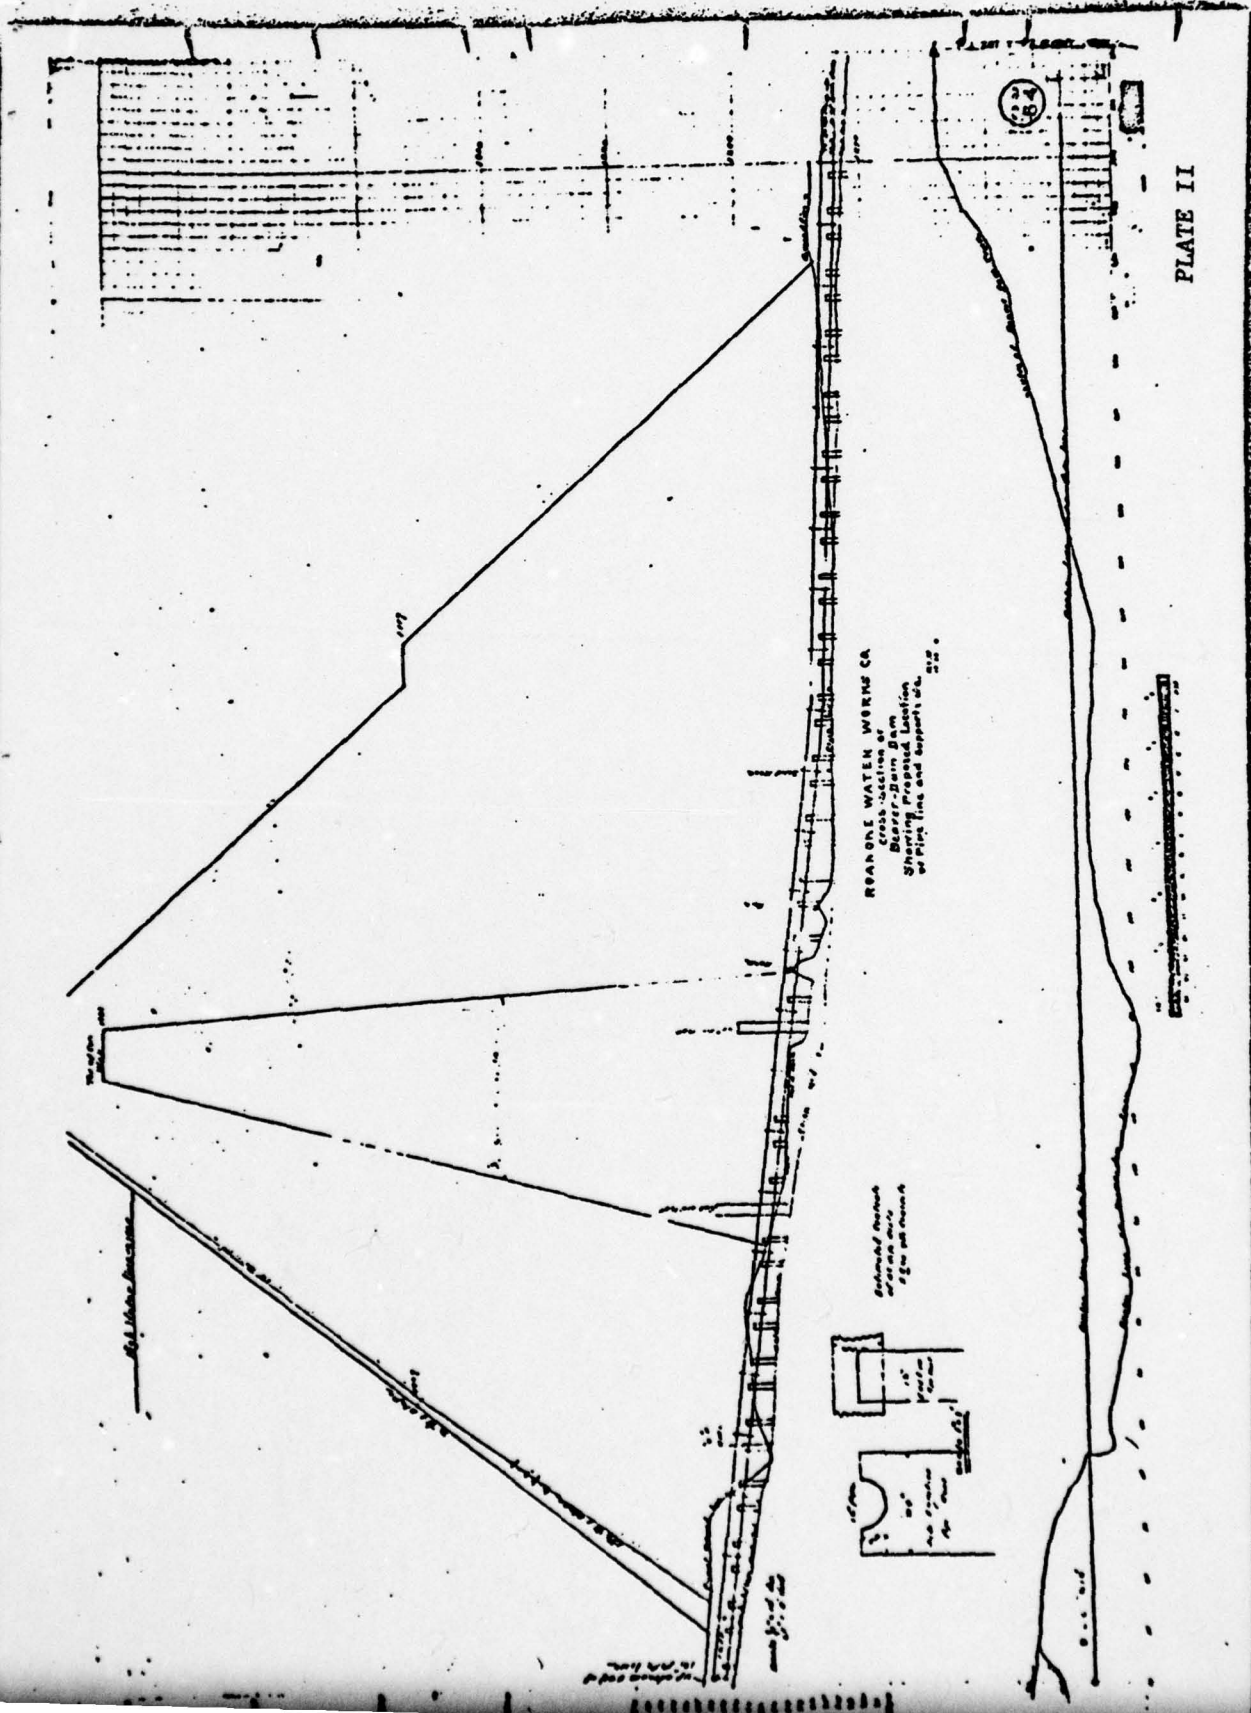
PLATE II

6.2.2 Stability: There are no stability calculations for any loading conditions on the dam. The structure was designed in 1924 and it is seriously doubted any analyses were performed. Based on the drawings, the embankment is 15 feet wide with a 1V:2H upstream slope. The downstream slope is also 1V:2H, but is benched at elevation 1907 or about midway down the slope. According to the guideline outlined in Design of Small Dams, U.S. Department of Interior, Bureau of

Reclamation, homogeneous earthfilled dams on stable foundations, the recommended minimum width for this type dam is 23 feet with side slopes of 1V:3H upstream, and 1V:2.5H downstream for clay/silt soils. Based on these guidelines, the width and slopes are inadequate.

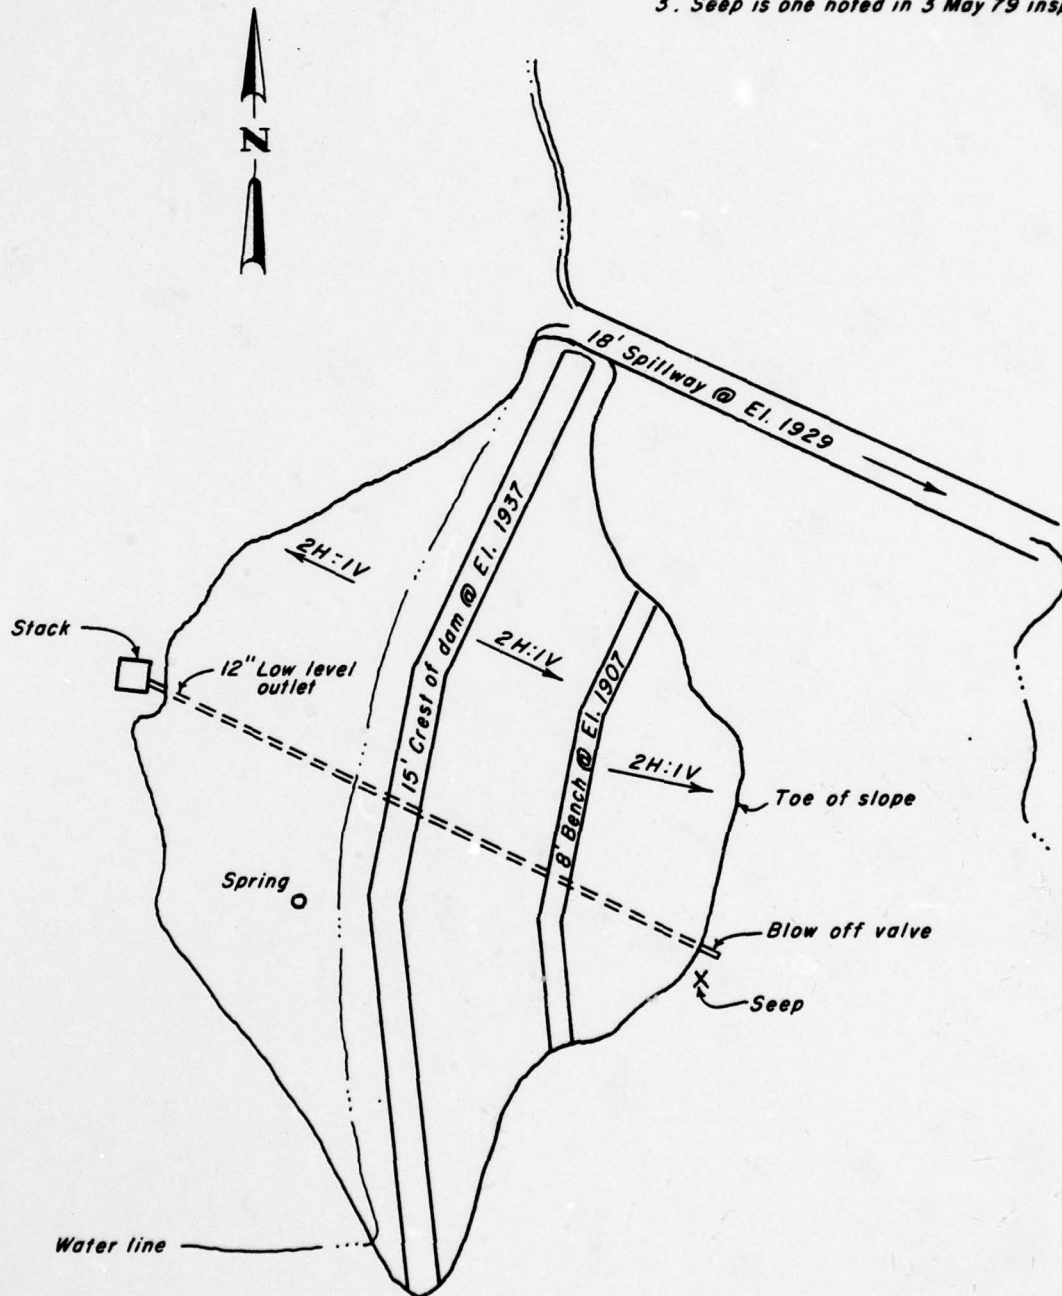
PLAN VIEW  
BEAVERDAM CREEK DAM  
BEDFORD, VIRGINIA  
PLATE IV  
6-27-79

1. Sketch made from field notes.
2. Spring is the one noted on PLATE I and noted in "Geology Report, Appendix IV."
3. Seep is one noted in 3 May 79 inspection.

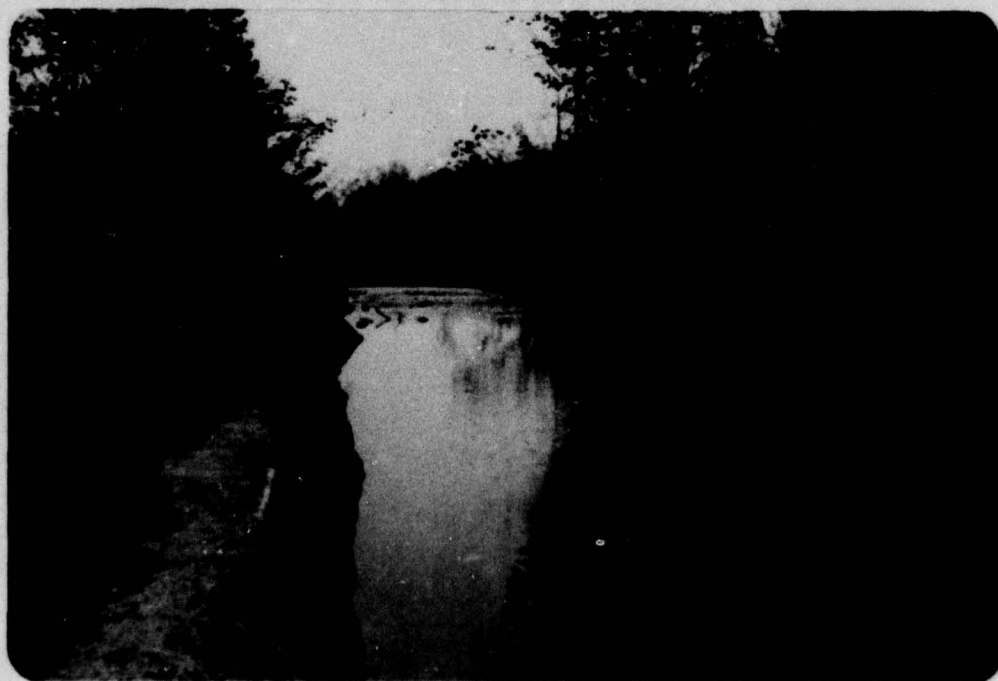
3.1.4 Spillway: The channel is concrete lined, shallow, free from debris, and in good condition, Appendix II, Photos 2, 3, and 4.

PHOTO #2 : EMERGENCY SPILLWAY
